HARTWELL LAKE PROJECT
Savannah River, Georgia And South Carolina

REHABILITATION OF CLEMSON UPPER DIVERSION DAM

CONTRACT NO. DACW21-83-C-0066

CONSTRUCTION FOUNDATION REPORT

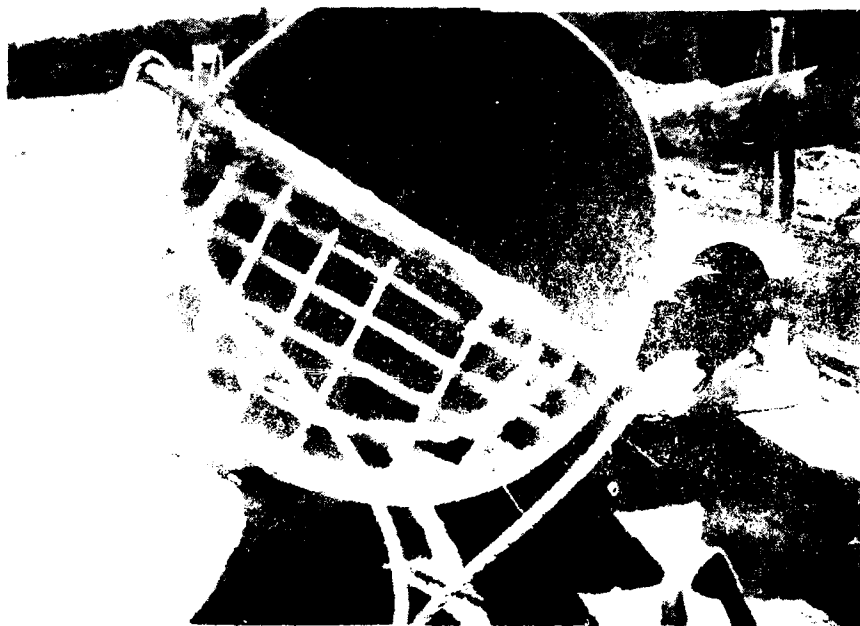
Photo 57 - Tremie hopper (missing one bar) used to remove lumps (May 5, 1984)
